WAYS TO MITIGATE

UTILITY LINE  
CLEARANCE VIOLATIONS

BY: LEIF CAMERON  
DISTRIBUTION ENGINEER

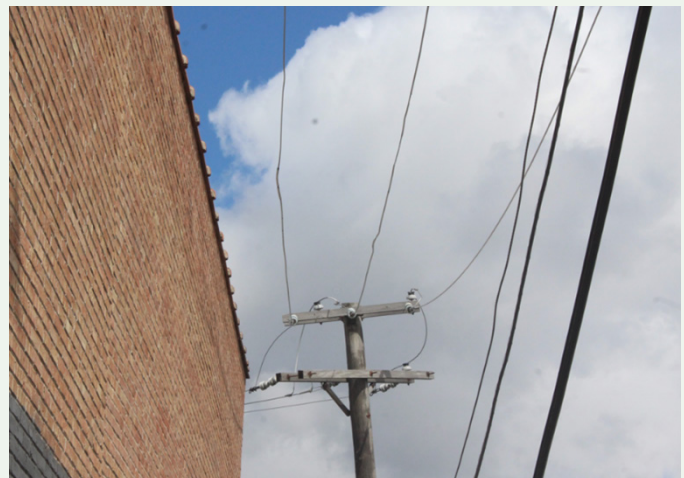
As I was photographing this site, an employee of the building came out to talk to me. He shared a recent incident where the roof of the building had caught fire due to a live conductor blowing into it. No wonder this location was flagged for a clearance violation!

- ⚠️ **Clearance Violation:** Conductor is placed within 7ft. 6in. horizontally of the building.
- ✅ **Mitigation:** Increase conductor height to meet vertical clearance requirements to the top of the building.

The pole line pictured above runs along a fence that separates a narrow walkway and a parking lot. Unfortunately, I was unable to relocate this pole in the horizontal direction, as that would impede on the parking lot and violate the existing utility easement. However, to fix the clearance issue, I used an alternative strategy. Instead, I increased the height of this pole and its adjacent counterpart to meet

vertical clearance to the roof. Making this adjustment eliminated the risk of the conductor blowing horizontally into the building and causing another fire.

**NOTE!** Horizontal clearances should also account for wind. Depending on the span length and wind force, this may add an additional 6 to 24 inches of horizontal clearance to account for.

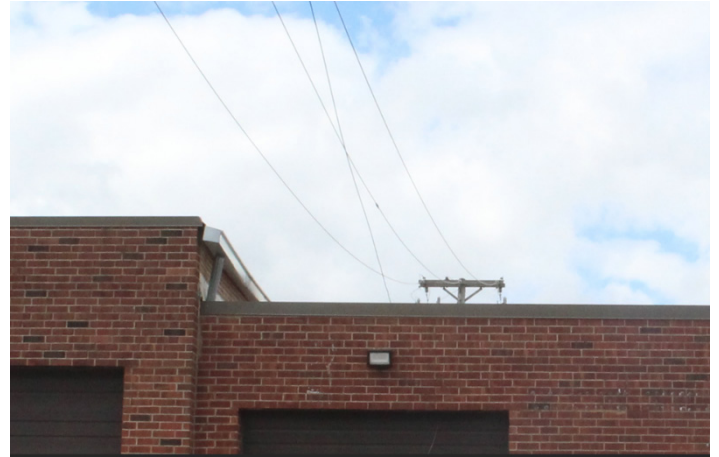
The original plan to rectify this vertical clearance issue involved increasing the heights of the pole pictured above and the adjacent one. This pole line runs through a parking lot that frequently experiences heavy truck traffic. To pass structural analysis of these taller poles and accommodate the new pole tension, the installation of a down guy was deemed necessary. However, using a down guy proposed a new challenge as it would not offer enough space for the parking lot's truck traffic.

- ⚠️ **Clearance Violation:** Existing conductor is within 13ft. 6in. vertically to the building.
- ✅ **Mitigation:** Remove the overhead conductor and neutral; and bury underground to avoid the building

I decided to install new primary riser poles on each side of the building to avoid the possibility of a truck hitting the down guy's anchor. The primary conductor and the neutral wire can be hidden underground by setting up a new cable around the building. This new cable will bring electricity to the transformer pole,

which will then supply power to the building from the opposite side. Using this technique allows the building to get its power supply without any visible wires above the roof.

It's important to note that vertical building clearances can vary by one foot or more depending on the voltage of the conductors and whether the roof is pedestrian accessible. If a designer is unsure whether a roof is pedestrian accessible, it is best practice to use the larger vertical clearance.

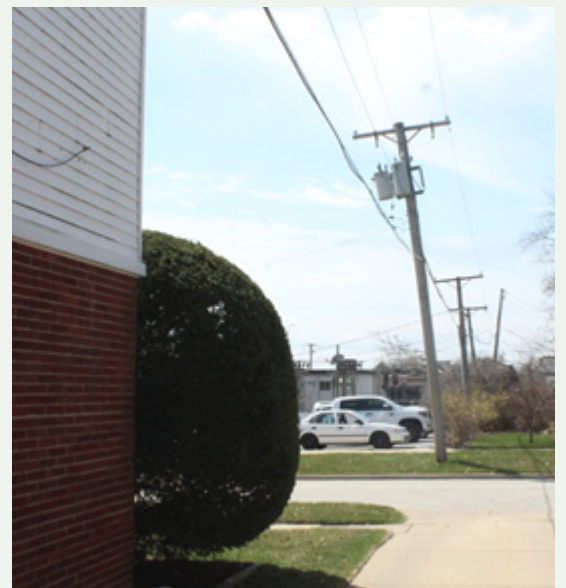
At first glance, this utility pole does not appear to be leaning much. However, a closer look tells a different story. If you draw an imaginary vertical line from the base of the pole, it will align with the far-right conductor on the cross arm, where the pole top of a perfectly straight pole would be located. Replacing the pole without any reframing will inevitably result in the same situation in the future.

- ⚠️ **Clearance Violation:** Existing conductor is within 7ft. 6in. horizontally to the building.
- ✅ **Mitigation:** Replace and reframe the pole. Install alley arm on adjacent pole.

Analyzing the uneven horizontal tension explains the pole's leaning posture. There is a set of secondary conductors and communication fiber running from the pole to the left, as seen in the photo. The transformer bank is installed with one central transformer can and another on the same left side towards which the pole is leaning.

I repositioned the transformers to the center and right side of the pole to help balance the pole tension. The left conductor was relocated to the pole top to help increase the horizontal clearance. Lastly, the adjacent pole arm was replaced with an alley arm pointing away from the residence to meet the horizontal clearance. Due to these adjustments, there was no need for a guy on the right side of the featured pole. A comprehensive structural analysis was completed for the reframed poles and their adjacent counterparts to ensure no additional improvements were necessary.

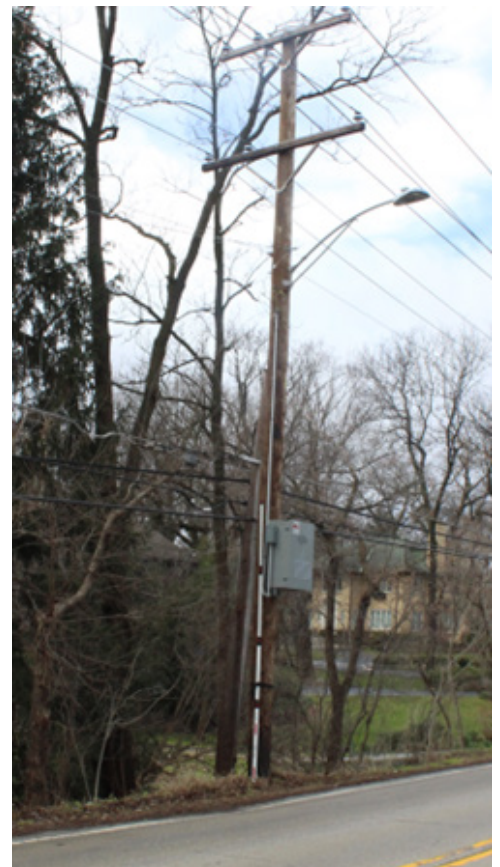
Clearance violations do not always pertain to the electrical conductors on a utility pole. Communication fibers must be installed below the distribution neutral or secondary conductors as seen on the pole pictured below. In this situation, clearance between the secondary conductor powering the light and the top communication fiber is met. However, the bottom communication fiber must also meet the clearance requirement to the road below.

**⚠ Clearance Violation:** Existing communication fibers are within 15ft. 6in. to the ground.

Vertical clearance to the ground varies depending on where the pole is located. Poles located where cars are not accessible, like a backyard, have the smallest clearances to ground. Clearances are largest where conductors run across roads. The 15ft. 6in. clearance discussed above is due to the pole lines running parallel to the road.

**✓ Mitigation:** Contact the communication companies and have them move their facilities higher on the pole.

Communication companies are responsible for relocating their facilities and ensuring vertical clearance to the road is achieved. On this project, I was able to successfully liaise with these companies to address the vertical clearance issue. For this issue to be solved, there must be sufficient space for the upward relocation of the fibers. There is ample space here to reposition the fibers and maintain a 4ft. vertical clearance to the secondary/neutral and 15ft. 6in. clearance to the road. No additional utility work is required at this location due to these convenient circumstances. If vertical clearance could not be met to the secondary/neutral, then a taller pole(s) would be required.

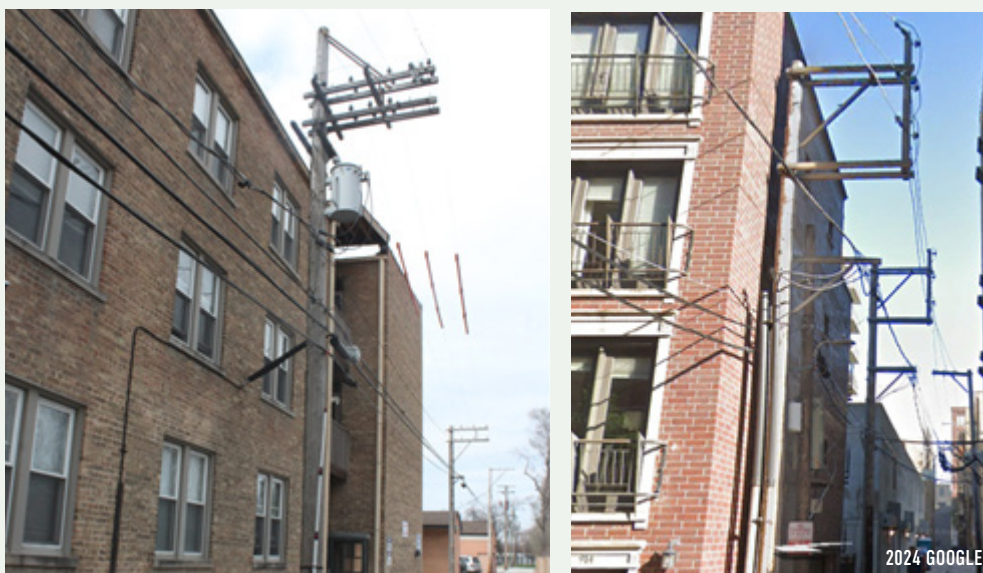
- ⚠️ **Clearance Violation:** Existing conductor is within 7ft. 6in. horizontally to the building (pictured on the left photo above).
- ✅ **Mitigation:** Reframe pole and adjacent poles and use the “box build” method (example shown on the right photo above).

As a safety precaution, the conductors on the right span of the pole, as depicted in the photograph, are covered prior to this line clearance design. The rear side of the apartment building is nearly in line with the pole. Unfortunately, an alley arm construction would not offer sufficient horizontal clearance for the left and middle conductors.

To mitigate the clearance issue, I employed a “box build” strategy. This method ensures that the conductors are safely distanced from the building, mitigating any potential risks. The adjacent poles were also reframed using the “box build” design to provide adequate clearance for both spans alongside the building. An example of the “box build” can be seen above. Notice how the conductors are attached vertically instead of horizontally to meet clearance to the building’s side.

Structural analysis should be completed on both the target poles and adjacent poles when using this build. The “box build” may require additional design work on the adjacent poles to account for the new tensions from the conductors.
